Manhole Inspection Summary

Manhole # S13UU1002MH

Location Address: **BELVEDERE AVE**

Cross Street: **NORTHERN PKWY**

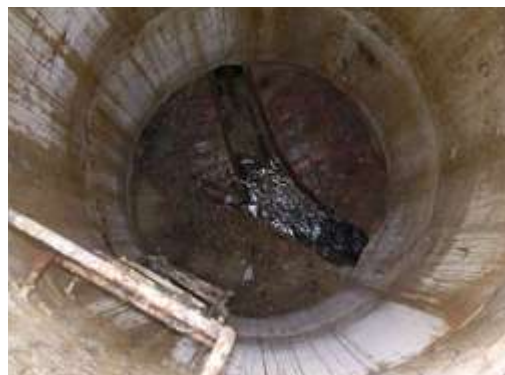
Top View

Evidence of surcharge - Bench debris.
Channel debris.

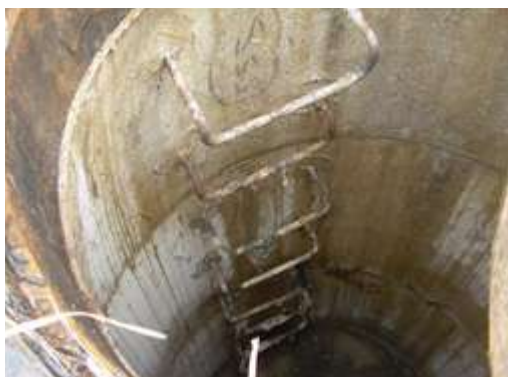
Defect

Infiltration: ☐ None ☒ **Joint** ☐ Cracks ☐ Mortar ☐ Roots ☒ **Wall**

Corbel and Barrel infiltration.

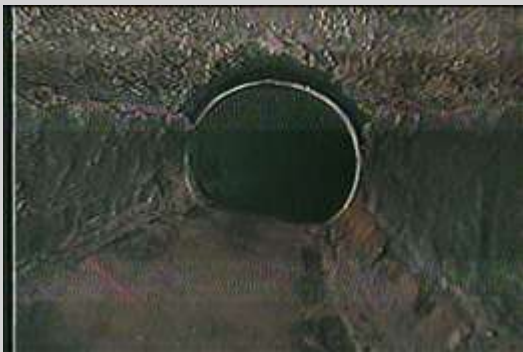
8 in. Circular Gravity Sewer Pipe Out @ 12 O'Clock

Comments **The O12 pipe seal is not flush to the pipe.**

Deposits: ☐ None ☒ **Mud** ☐ Sludge ☒ **Debris** ☐ Grease

Silt Depth: **0.5** (in.) Deposits Extent: **Light**

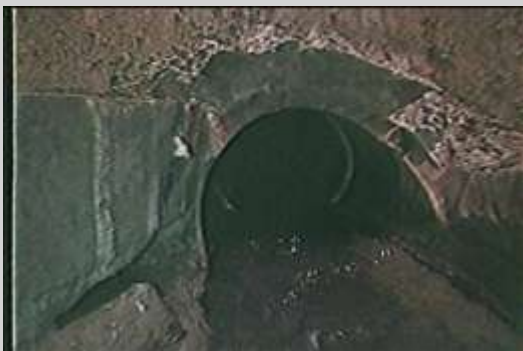
8 in. Circular Gravity Sewer Pipe In @ 5 O'Clock

Channel deterioration.

Deposits: ☐ None ☒ **Mud** ☐ Sludge ☒ **Debris** ☐ Grease
